# Manhole Inspection Summary

Manhole # S15Q\_\_022MH

Insp Date: **7/1/09 1:55 PM**

**Location** Address: **Wilkens Ave.**

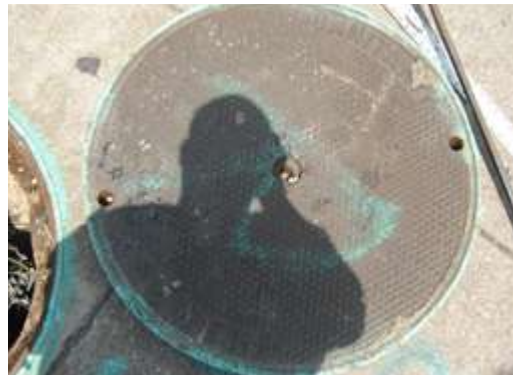
Cover

Comments **Cover should be bolted down; air volume at times causes MH lid to pop up. This structure drains into 78" trunk line.**

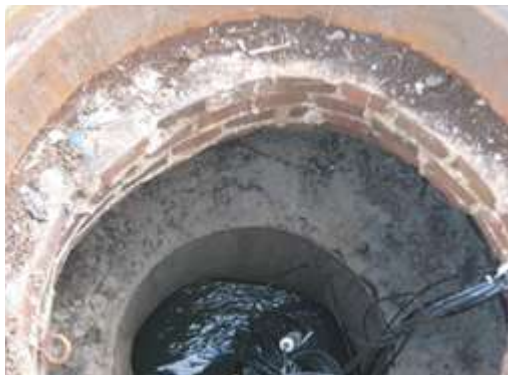
### Defect 1

**Frame** Offset: **3** (in.) Condition: ☒ Sound ☐ Cracked ☐ Leaks

Frame offset

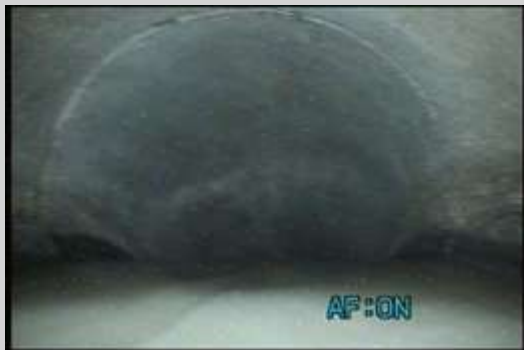
12 O'Clock Outflow

27 in. Circular Gravity Sewer  
Pipe Out @ 12 O'Clock

Infiltration: **None** Pipe Seal Cond: **Sound**

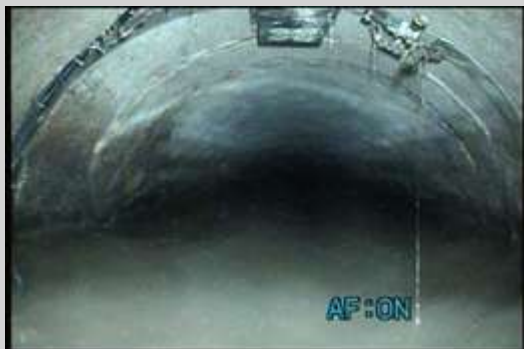
6 O'Clock Inflow

27 in. Circular Gravity Sewer  
Pipe In @ 6 O'Clock

Invert Depth: **8.28** (ft.) Flow Characteristics: **Turbulent**
